PASSAIC RIVER BASIN

SYLVA LAKE DAM

PHASE I INSPECTION REPORT  
NATIONAL DAM SAFETY PROGRAM

NJ 00391

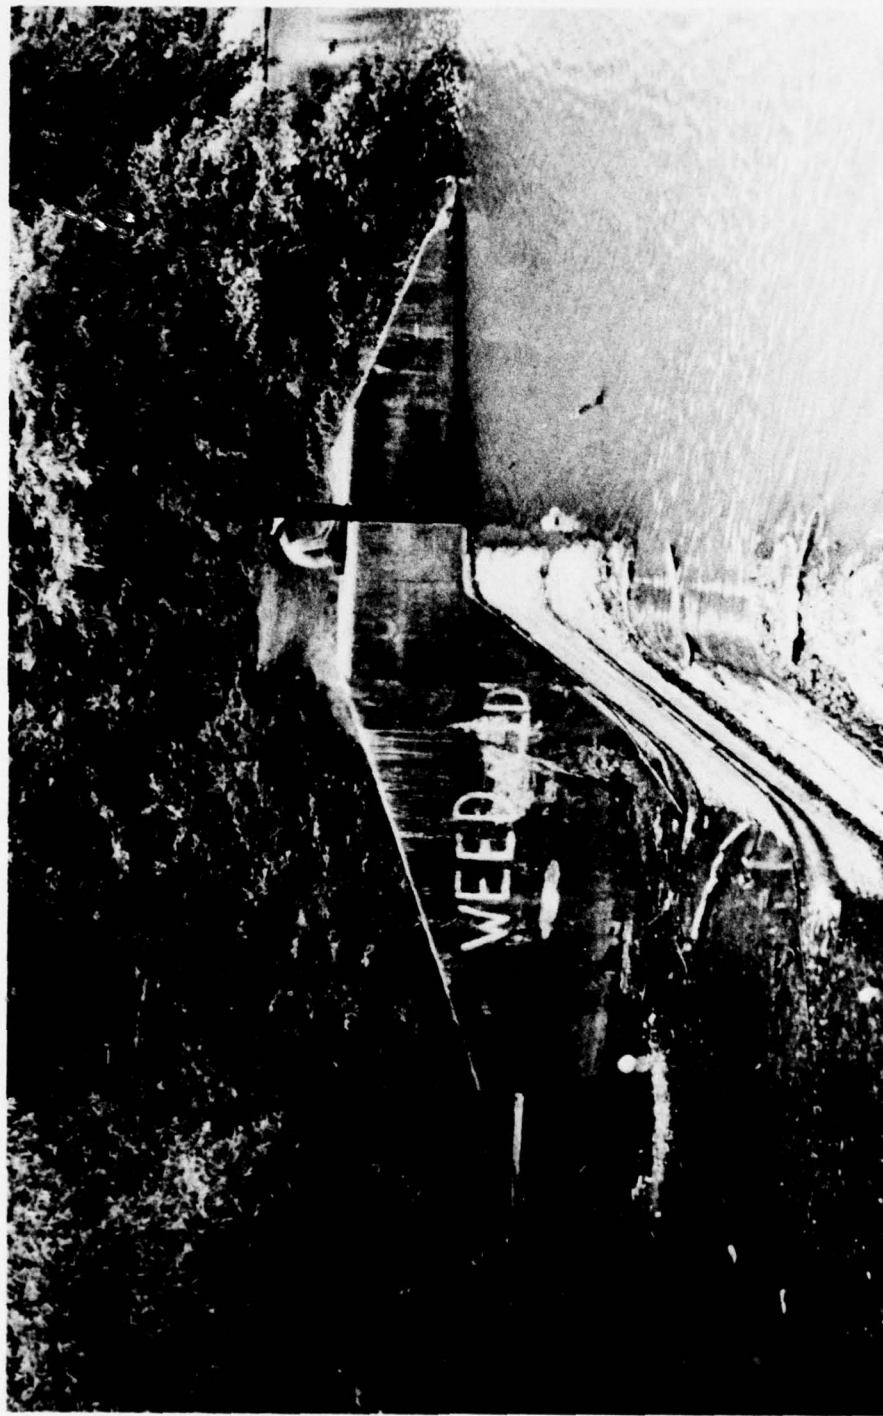
OVERALL VIEW OF DAM

The visual inspection and review of engineering data, made in June and July 1978, indicate that deficiencies exist in the dam to a degree warranting correction without undue delay, although emergency attention is not required. The dam was found to be in poor overall condition at the time of visual inspection. A detailed topographic survey of the left abutment and reservoir area should be performed to determine the appropriate location required to reconstruct the top of the existing dike to top of dam elevation and to provide proper drainage for adjacent areas. It is recommended that the seriously spalled and deteriorated areas on the concrete spillway weir, downstream spillway face, spillway wing walls, and discharge channel apron be repaired. Obstructions should be removed from the downstream channel. The left stream channel should be cleared, shaped and stabilized. The scour hole at the end of the apron should be repaired. Facilities for draining the lake should be restored. The bare slightly eroded area on the downstream slope should be graded and reseeded. The earth embankment should be cleared of trees and shrubs, properly graded, and replanted with well maintained grass.

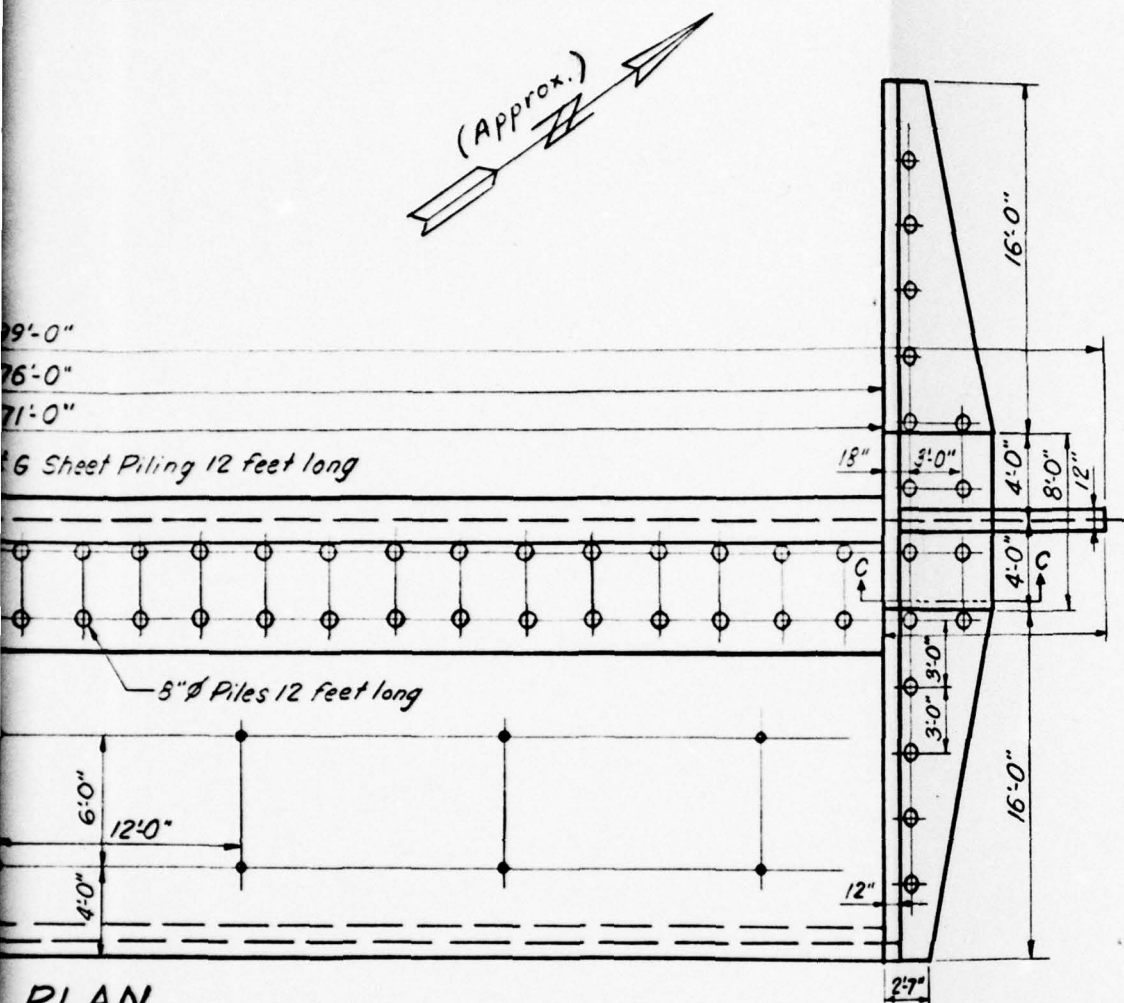
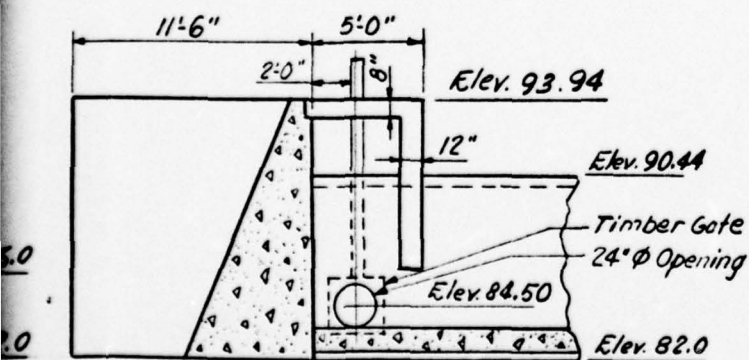
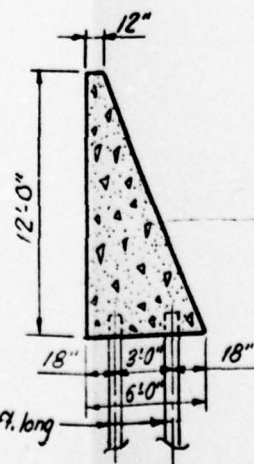
#### PLATE 3

NEW JERSEY  
STATE TEACHERS COLLEGE  
SYLVA LAKE DAM  
SPILLWAY

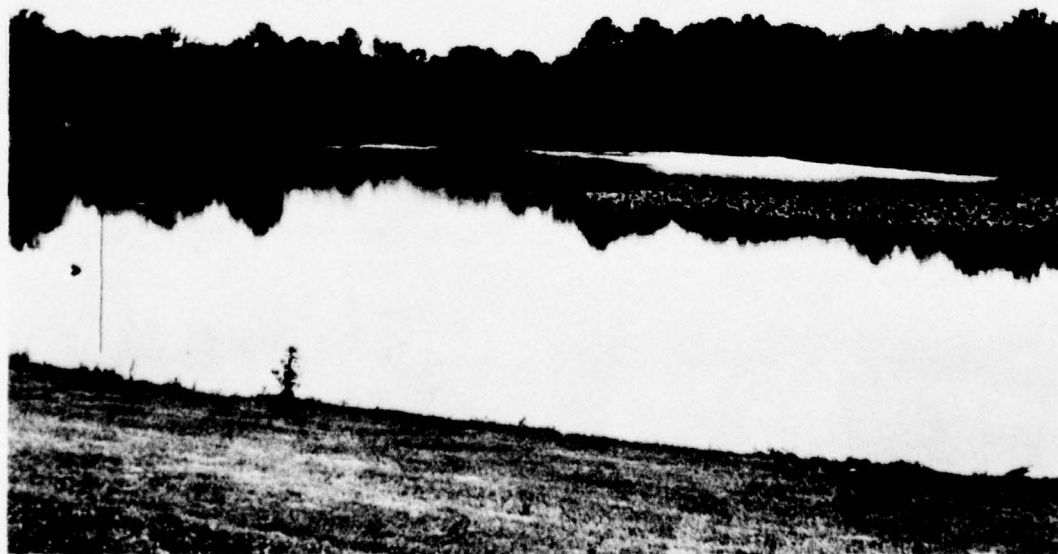
PHOTO 14

- d. Reservoir Area - It was noted that heavy sediment deposition had taken place in the reservoir. Several islands of sediment and aquatic vegetation were located in the lake area.

- c. Reservoir - The sediment deposits in the lake area have seriously affected the lake's intended recreational use and also reduced its water volume. Consequently, in the event of failure, there is less volume of water that would be released to cause damaging affects downstream.

Photo 14 - View of Upper End of Lake Sylva Showing Aquatic  
Growth Resulting From Heavy Siltation of Lake -  
24 June 1978.
